Manhole Inspection Summary

Manhole # S47II_031MH

Insp Date: **5/1/08 10:47 AM**

Location Address: **Oliver St**

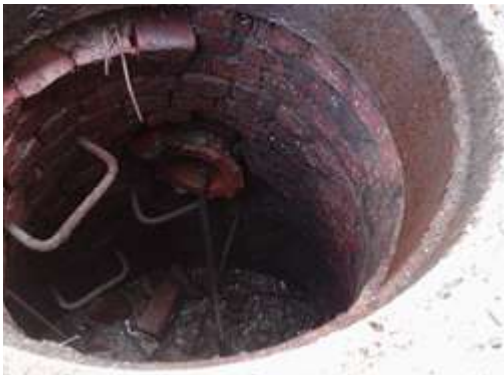
Defect 2

Deterioration

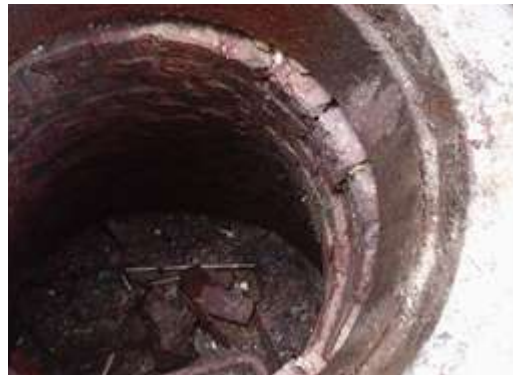
Defect 1

Condition: ☐ Sound ☐ Cracked ☐ Root Intrusion ☒ **Loose Brick** ☐ Deteriorated

Infiltration: ☐ None ☐ Joint ☐ Cracks ☒ **Mortar** ☐ Roots ☐ Wall

Loose Bricks

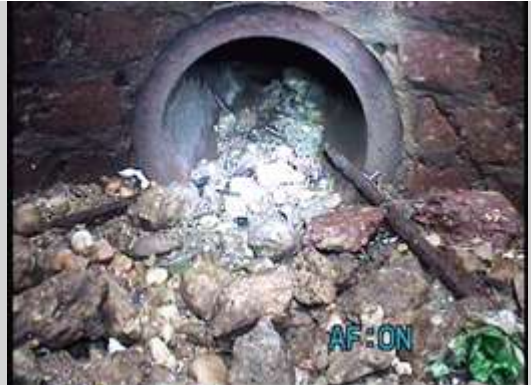
12 O'Clock Outflow

8 in. Circular Gravity Sewer
Pipe Out @ 12 O'Clock

Pipe Height: **8.4** (in.) Rod and Bar (Angled)
Pipe Material: **Clay** ☐ Pipe Lined
Invert Depth: **6.80** (ft.) Flow Characteristics: **None**
Deposits: ☐ None ☐ Mud ☐ Sludge ☒ **Debris** ☐ Grease
Silt Depth: **4** (in.) Deposits Extent: **Medium**
Infiltration: **None** Pipe Seal Cond: **Sound**

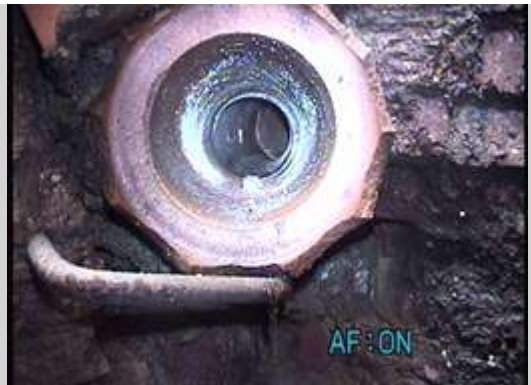
11 O'Clock Inflow

6 in. Circular Gravity Sewer
Pipe In @ 11 O'Clock

Pipe Height: **6** (in.) Rod and Bar (Angled)
Pipe Material: **Clay** ☐ Pipe Lined
Invert Depth: **3.40** (ft.) Flow Characteristics: **None**
Deposits: ☒ **None** ☐ Mud ☐ Sludge ☐ Debris ☐ Grease
Silt Depth: (in.) Deposits Extent:
Infiltration: **None** Pipe Seal Cond: **Sound**

Connects To: **House connection / Service line**

☒ **Possible Illicit Connection**
